NACA TN 2180

## EFFECTIVENESS OF MOLYBDENUM DISULFIDE AS A FRETTING-CORROSION INHIBITOR

By Douglas Godfrey and Edmond E. Bisson

Lewis Flight Propulsion Laboratory  
Cleveland, Ohio

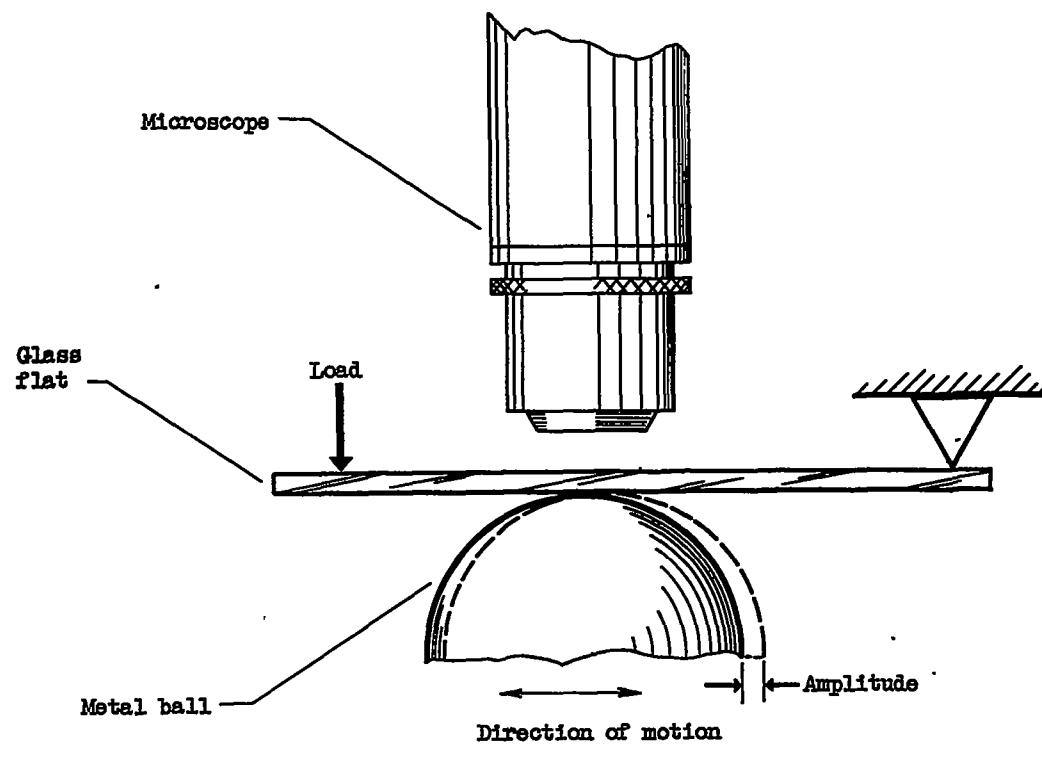
(a) Steel ball against glass flat.

Steel ball against glass flat. - Part of the experiments were conducted with essentially the same apparatus as that described in reference 2 by which fretting corrosion suitable for microscopic study was produced. A 1/2-inch-diameter chrome-alloy steel (SAE 52100) ball (surface finish, 3 to 4 microin. rms) was vibrated in contact with a clean glass microscope slide at a frequency of 120 cycles per second, an amplitude of 0.001 inch, and a load of 0.2 pound (calculated Hertz surface stress of 35,000 lb/sq in.). A diagrammatic sketch of the apparatus is presented in figure 1(a).

Figure 1. - Schematic diagram of fretting-corrosion apparatus.

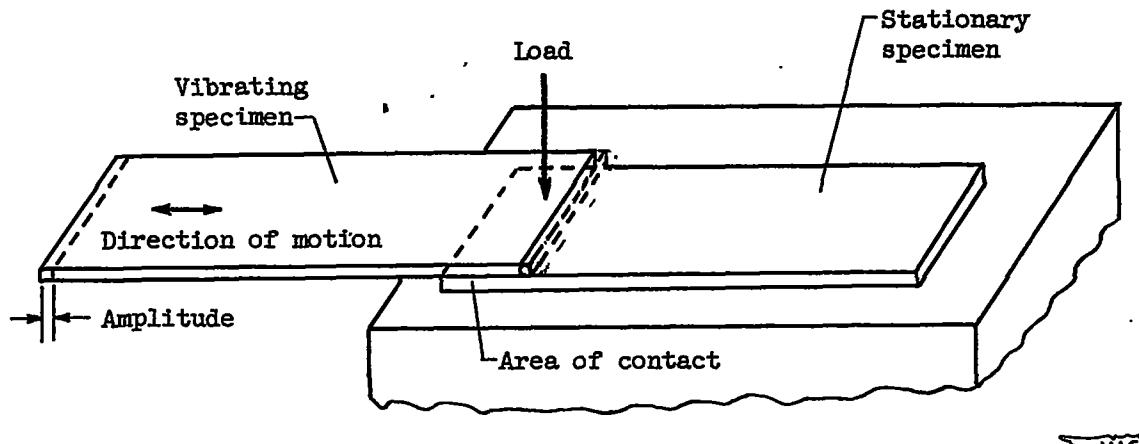
(b) Steel flat against steel flat.

Steel flat against steel flat. - In addition to the method of microscopic observation using steel vibrating in contact with glass, experiments were conducted with steel vibrating in contact with steel for better simulation of actual cases. A simple apparatus was used in which one clean flat specimen of blue Swedish spring steel was vibrated in contact with another at a frequency of 15 cycles per second, an amplitude of approximately 0.003 inch, and a nominal pressure of 20 pounds per square inch. A diagrammatic sketch of this apparatus is shown in figure 1(b). Swedish spring steel was chosen because, in practical use, this material is susceptible to failures by fretting corrosion.
